Flagler Mold Testing and Inspection

IAC2 Complete Mold Inspection Report

123 Main St, East Florida, FL 12345
Inspection prepared for: Sample Sample
Date of Inspection: 11/1/2024

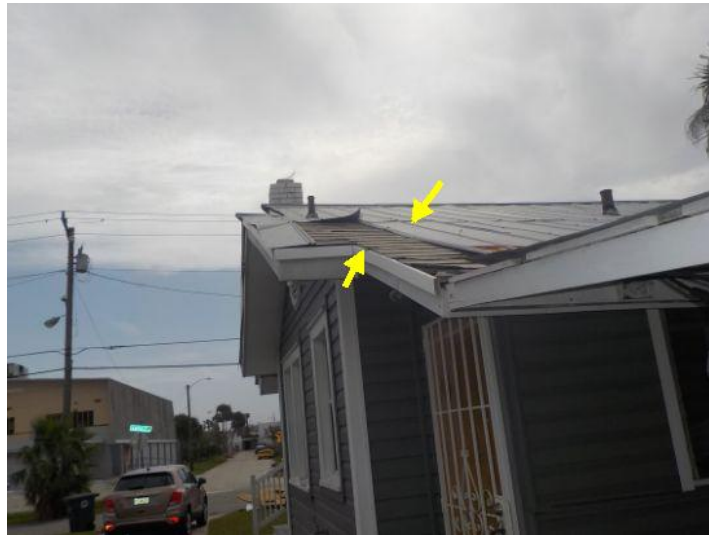
Roof Roof damages

Missing shingles

Recommend estimates from roofing contractor to repair missing shingles and damaged roof areas.

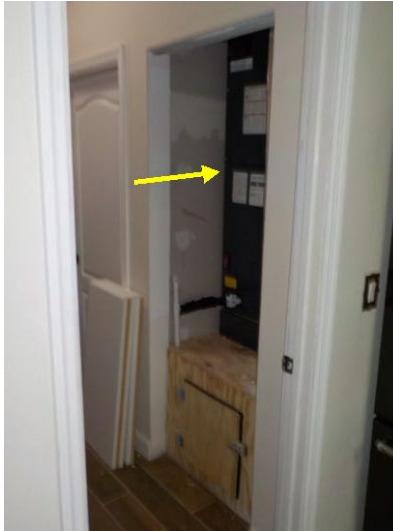
The air handler appears to need cleaning and servicing. We recommend having a licensed HVAC technician come in and service the unit on a regular basis as a routine maintenance item.

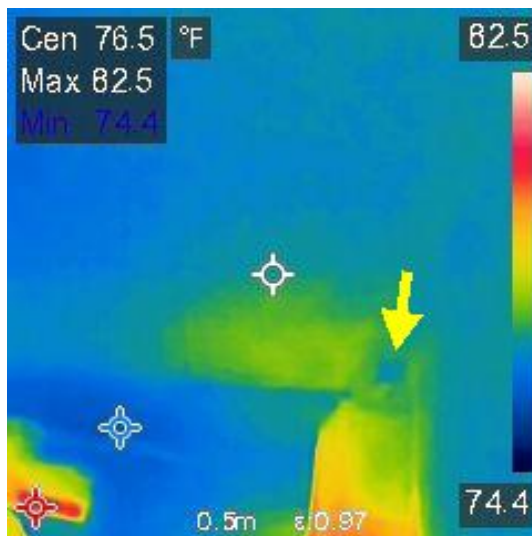
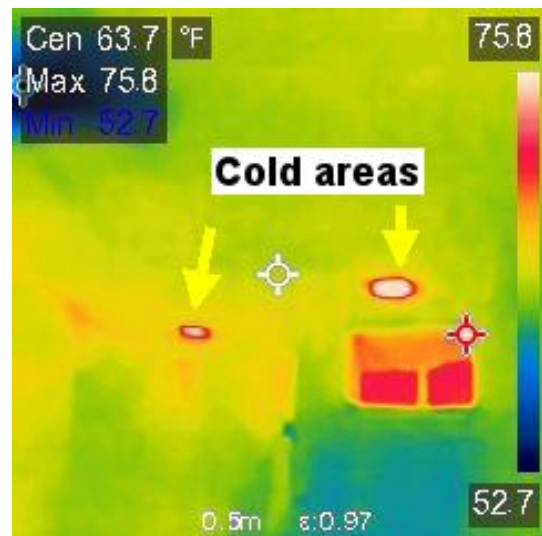
Note Infrared readings show temperature differences indicating trouble areas of concern.

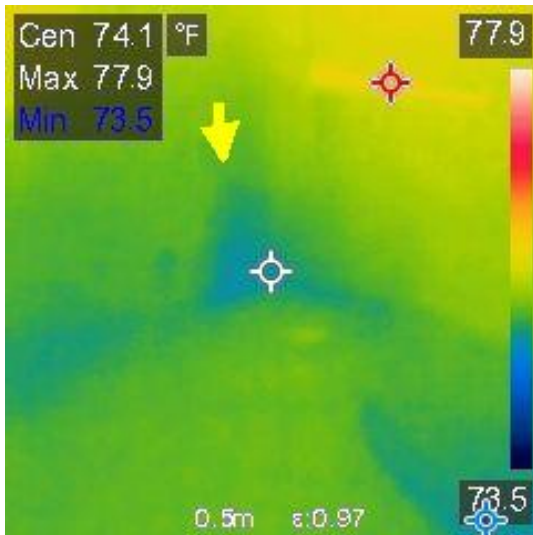
Note Infrared readings show temperature differences indicating trouble areas of concern.

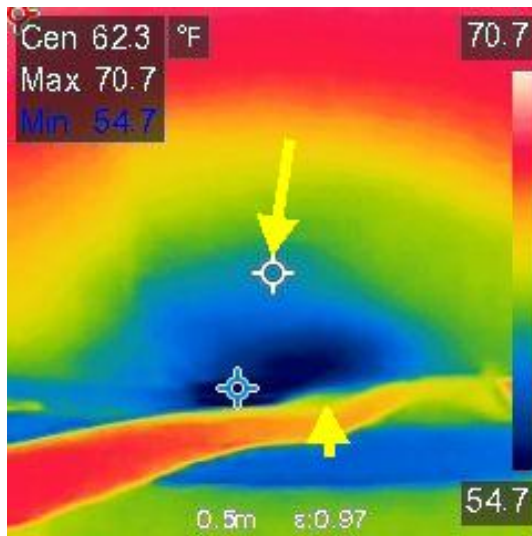
• There is evidence of moisture intrusion Our moisture measuring instruments reveal a 100% level of moisture in the flooring and drywall in the living room area. It is recommended that a licensed Mold remediation contractor be called in to remove the affected flooring and drywall and evaluate any further damage. At this time the source of moisture at the flooring should be addressed.

Note Infrared readings show temperature differences indicating trouble areas of concern.

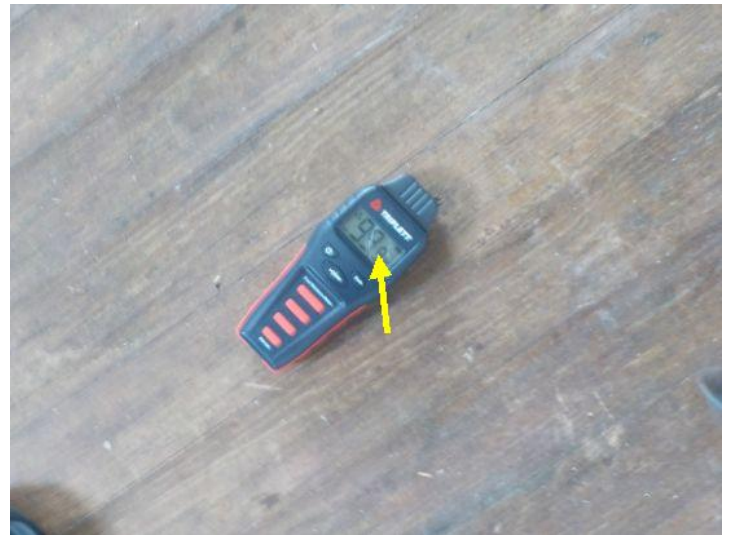
There is evidence of moisture intrusion Our moisture measuring instruments reveal a 100% level of moisture in the flooring and drywall in the living room area. It is recommended that a licensed Mold remediation contractor be called in to remove the affected flooring and drywall and evaluate any further damage. At this time the source of moisture at the flooring should be addressed.

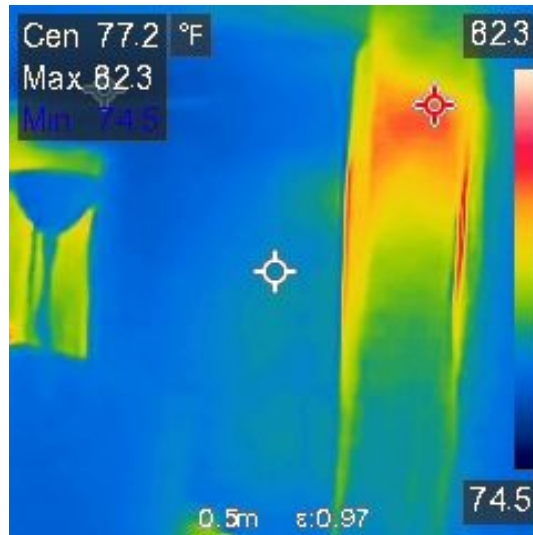
The **A/C** unit appears to be inoperable temperatures are above 80* recommend repair and use A/C to keep temperatures between 72-78* for optimal comfort.

Note Infrared readings show temperature differences indicating trouble areas of concern.
